***ADVANCED HOME INSPECTION***  
805 Plantation Drive, New Bern, NC 28562  
252-633-5858

**A Report on the Conditions at**

**123 Main Street  
New Bern, NC 28562**

**On June 15, 2009**

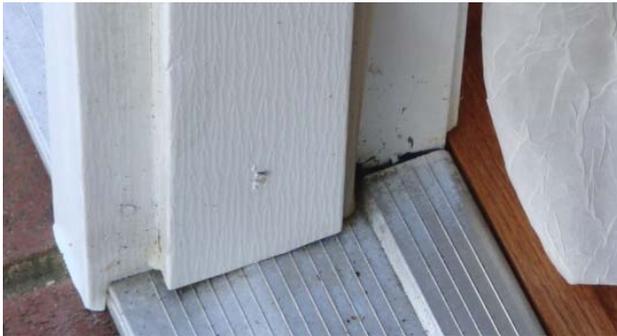
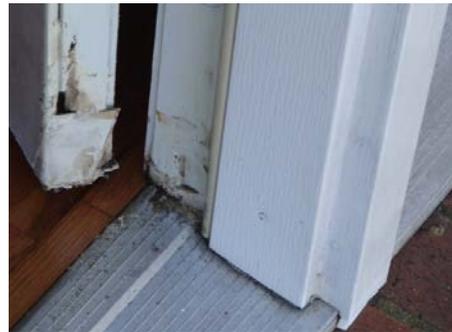
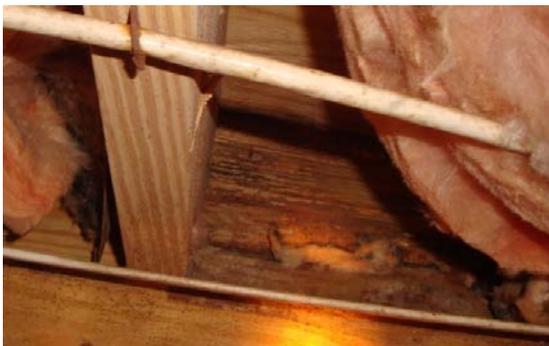
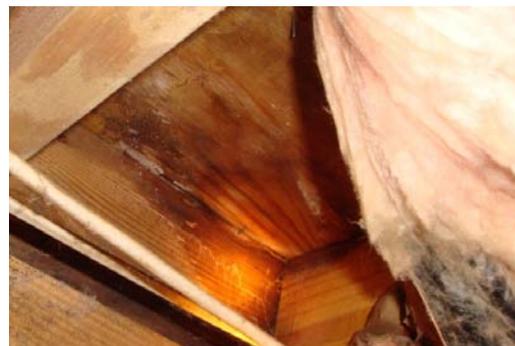
- 1.) At the rear French door of the family room to the wood deck, there is visible deterioration at the lower left and right side door frame and deterioration to the lower door itself. As viewed from the crawl space, there is visible staining and deterioration at the wood framing and subflooring below the door with possible hidden damage. Have a licensed general contractor determine the full extent of damage and perform all needed repairs and corrections to ensure that the same problem doesn't occur again.

- 1.) At the rear French door to the family room to the wood deck, there is visible deterioration at the lower left and right side door frame and deterioration to the lower door itself. As viewed from the crawl space, there is visible staining and deterioration at the wood framing and subflooring below the door with possible hidden damage. Have a licensed general contractor determine the full extent of damage and perform all needed repairs and corrections to ensure that the same problem doesn't occur again.

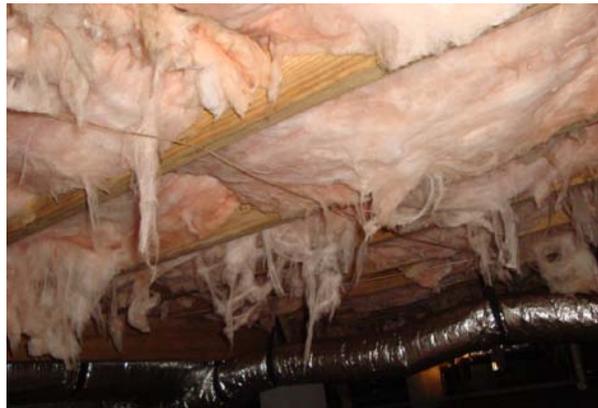
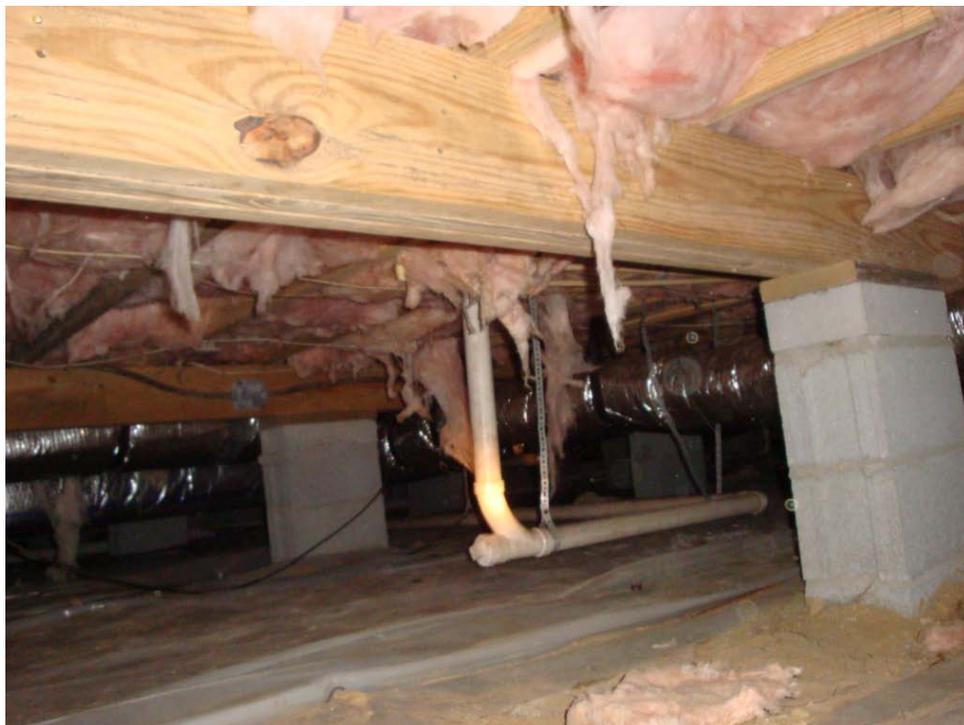
- 2.) As viewed from the crawl there are strands of floor insulation pulling down. This is typically due to moisture absorption. Most of this is happening at inner areas of the crawl space away from the foundation vents. Moisture absorption causes insulation to lose its effectiveness and is an indication of a condensation problem which could lead to damage and deterioration of the wood framing. Have a licensed general contractor evaluate and perform all needed replacement of floor insulation and repairs to correct this problem.

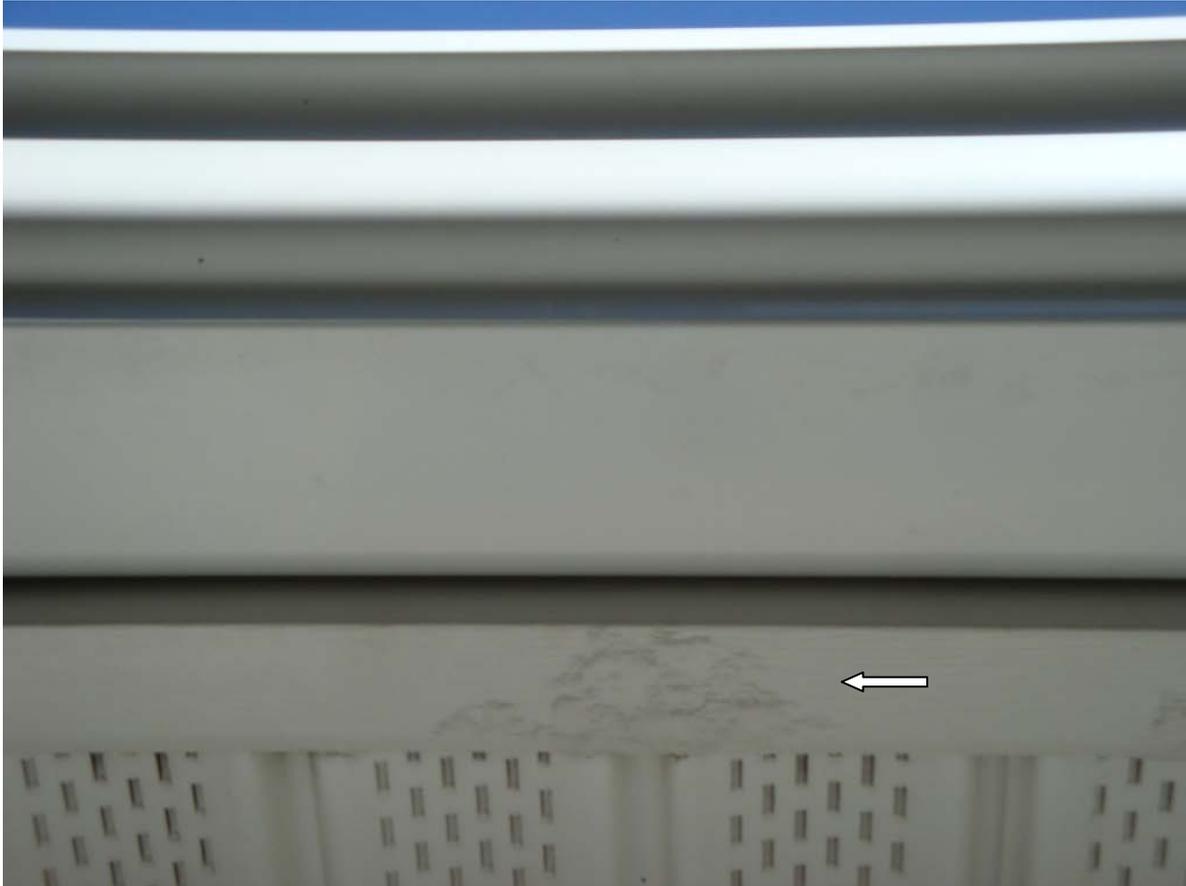
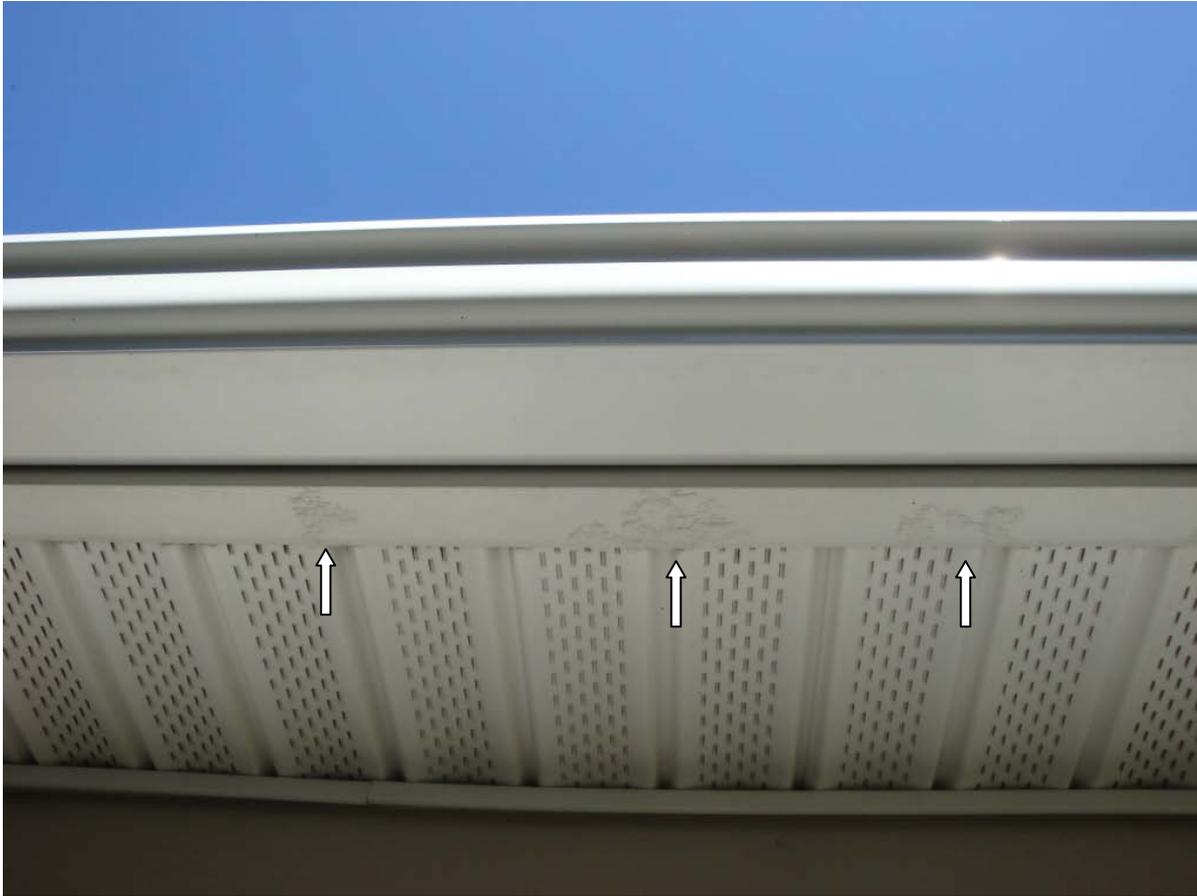
- 1.) The factory paint finish at various locations of the metal fascia cladding is failing (paint bubbling up). Most of the bubbling paint finish is at the left side of the house. Have a siding contractor install new metal fascia cladding at all the areas where the factory finish has failed.

- 1.) The factory paint finish at various locations of the metal fascia cladding is failing (paint bubbling up). Most of the bubbling paint finish is at the left side of the house. Have a siding contractor install new metal fascia cladding at all the areas where the factory finish has failed.**

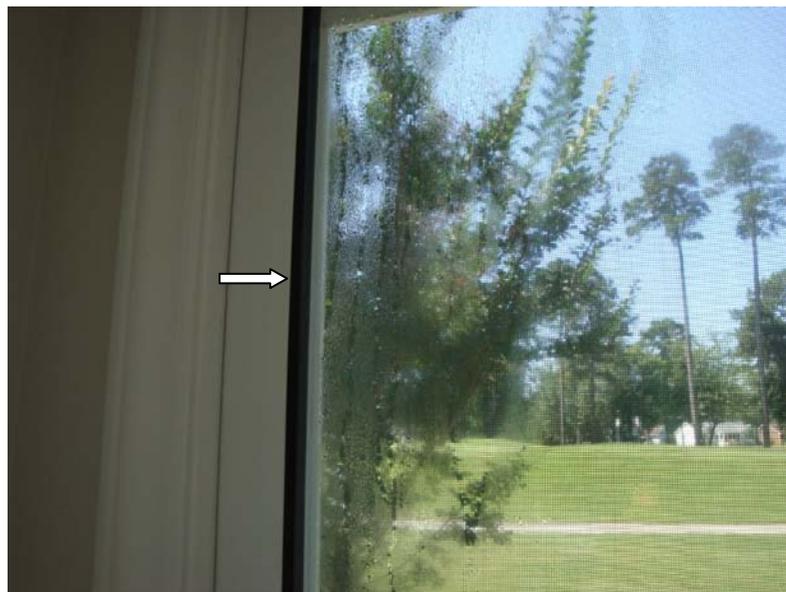
- 2.) **There is a broken thermal seal at the moveable slider door at the rear sunroom. The glass door has lost its vacuum between the two panes of glass which allows the moisture droplets in. This process causes staining on the glass and limits visibility. Have a window contractor perform replacement or repair.**

- 2.) There is a broken thermal seal at the moveable slider door at the rear sunroom. The glass door has lost its vacuum between the two panes of glass which allows the moisture droplets in. This process causes staining on the glass and limits visibility. Have a window contractor perform replacement or repair.**

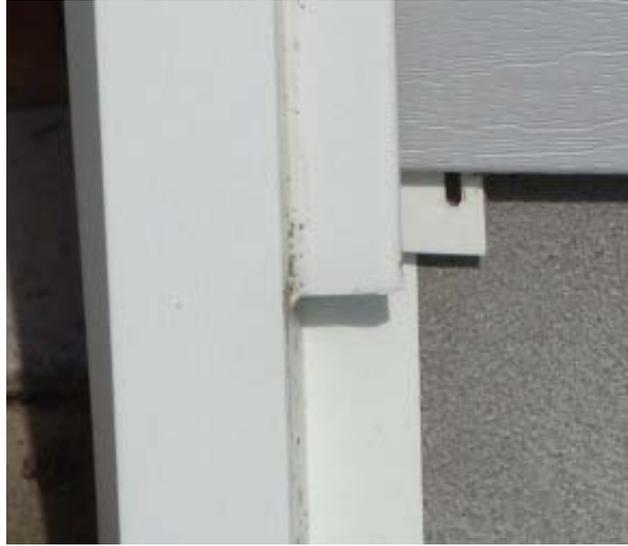
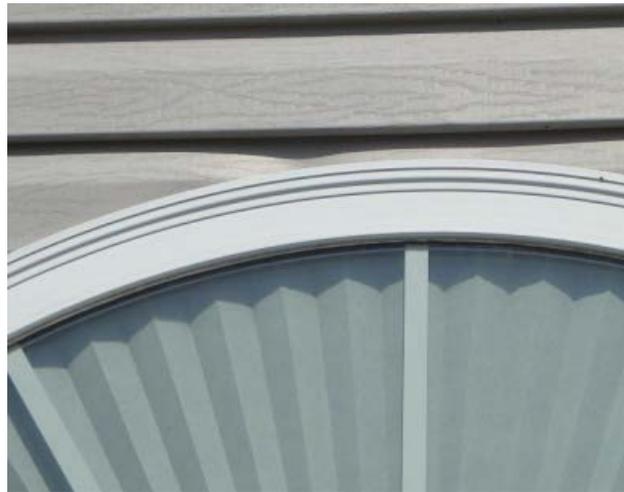
- 3.) At the front left corner, the bottom section of vinyl siding doesn't fully cover the corner mounting surface. This section of vinyl siding wasn't installed properly. At the top of the front left side window, there is a very bowed in section of vinyl siding. Have a vinyl siding contractor perform replacement and repair.

- 3.) At the front left corner, the bottom section of vinyl siding doesn't fully cover the corner mounting surface. This section of vinyl siding wasn't installed properly. At the top of the front left side window, there is a very bowed in section of vinyl siding. Have a vinyl siding contractor perform replacement and repair.**

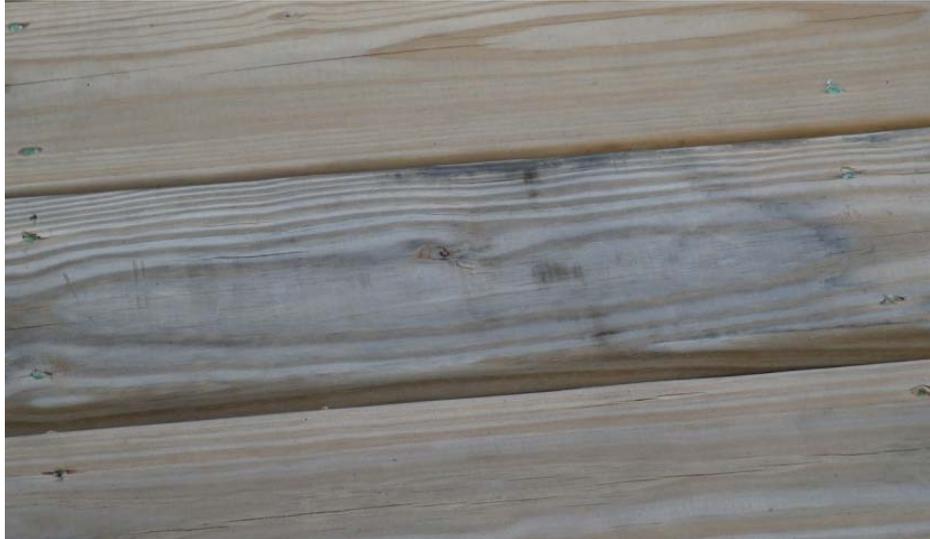
- 4.) **There is a raised up board at the left side of the rear deck. This is a tripping hazard which could cause possible injury. Have a licensed general contractor perform replacement or repair.**

- 4.) There is a raised up board at the left side of the rear deck. This is a tripping hazard which could cause possible injury. Have a licensed general contractor perform replacement or repair.**

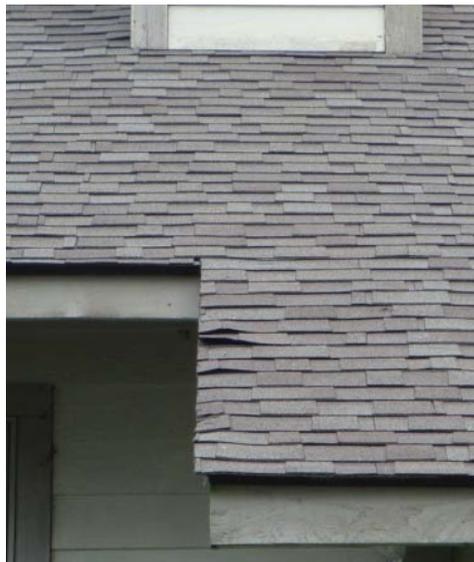
- 1.) **At the left side of the house below the chimney chase, there are a couple of bent up and damaged roof shingles. This can cause possible leaks and tears if wind gets caught under the bent up roof shingles. Have a roofer perform replacement & repair.**

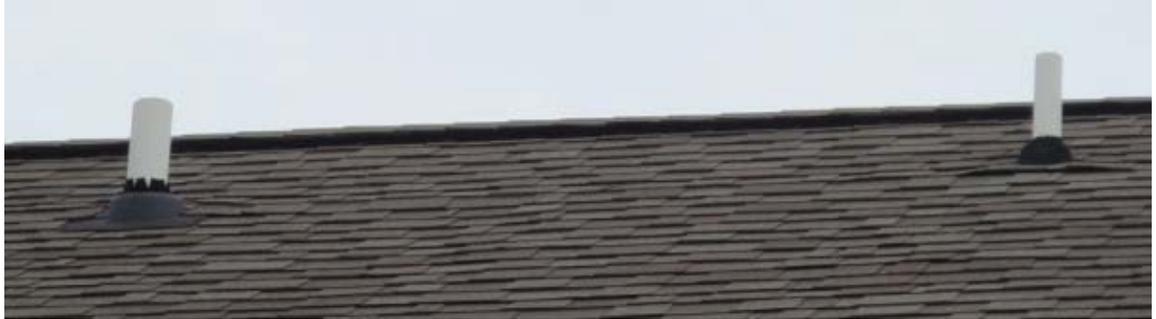
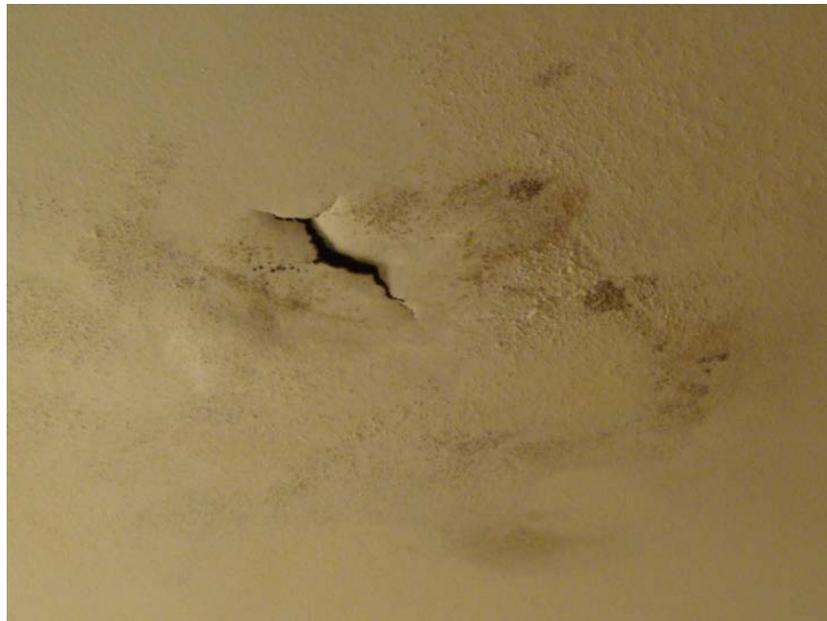
- 1.) **The rubber boots of the two rear plumbing vent stacks are torn. There is extensive visible damage at the ceiling of the bathroom and staining at the ceiling of the rear hallway. As viewed from the attic there is active leakage at the plumbing vents above these locations. Have a roofer and general licensed contractor replace the damaged rubber boots and perform all repairs at the stained roof sheathing, ceiling sheetrock, and any possible hidden damage.**

- 1.) The rubber boots of the two rear plumbing vent stacks are torn. There is extensive visible damage at the ceiling of the bathroom and staining at the ceiling of the rear hallway. As viewed from the attic there is active leakage at the plumbing vents above these locations. Have a roofer and general licensed contractor replace the damaged rubber boots and perform all repairs at the stained roof sheathing, ceiling sheetrock, and any possible hidden damage.
- 2.) At just about every location, the metal drip edge is poorly & improperly (not bent underneath the roof shingles) installed with large open end joints, lots of short pieces used (instead of one longer piece), and bent sections. This condition can allow water to get under the roof shingles and cause possible leakage and damage. Have a roofer or contractor perform all needed repairs.

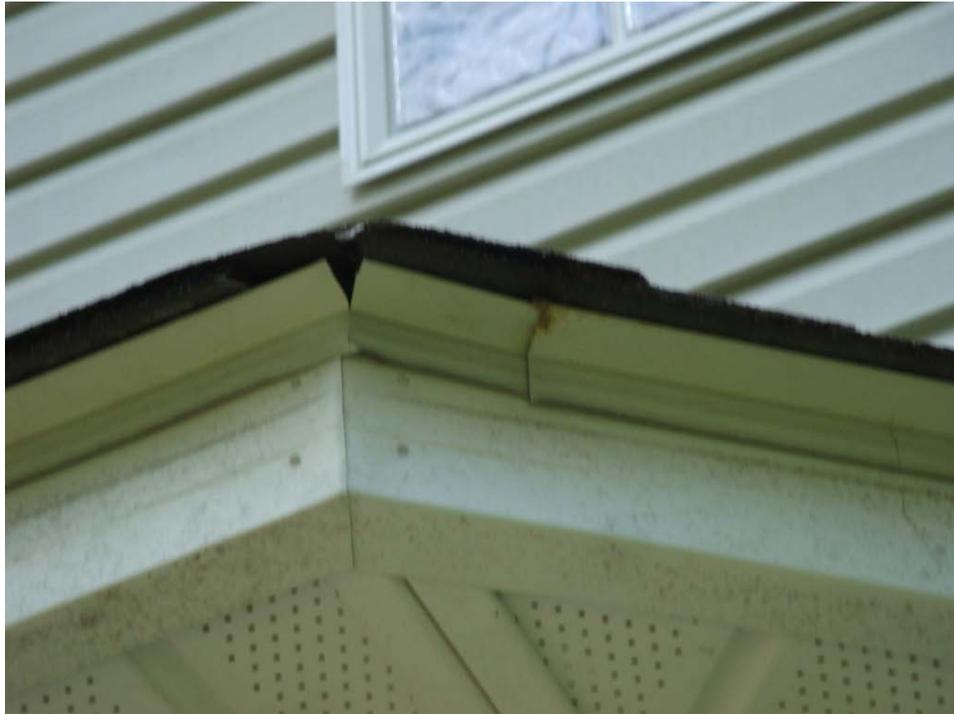
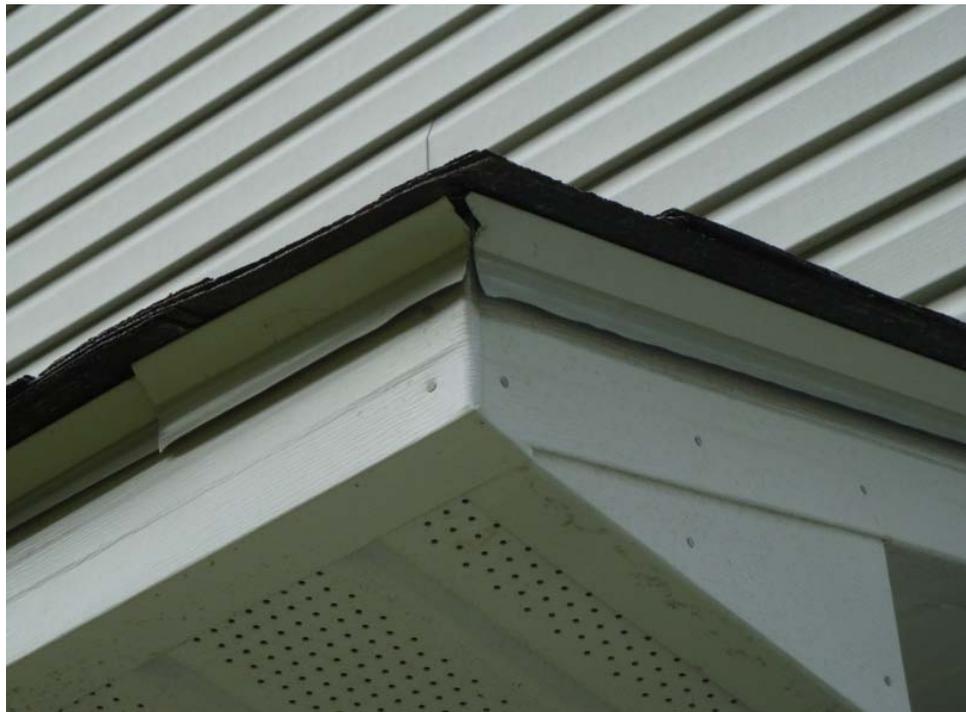
2.) At just about every location, the metal drip edge is poorly & improperly (not bent underneath the roof shingles) installed with large open end joints, lots of short pieces used (instead of one longer piece), and bent sections. This condition can allow water to get under the roof shingles and cause possible leakage and damage. Have a roofer or contractor perform all needed repairs.

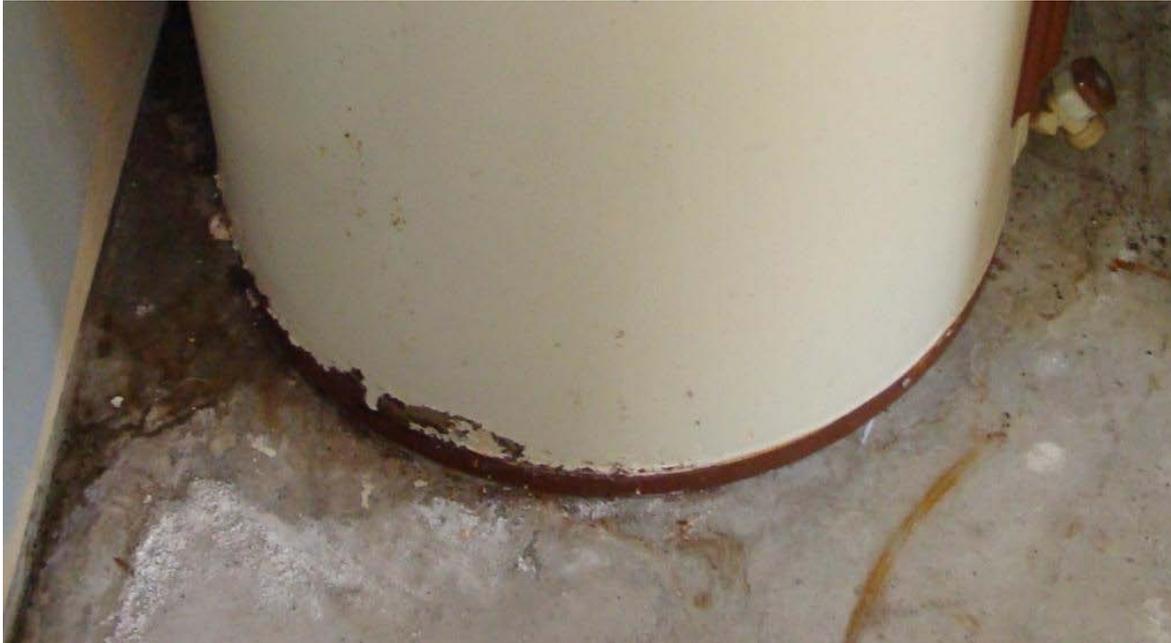
- 1.) The water heater located in the garage is rusted and leaking from the bottom. The unit has reached the end of its useful life and needs to be replaced. Have a licensed plumber perform replacement.**

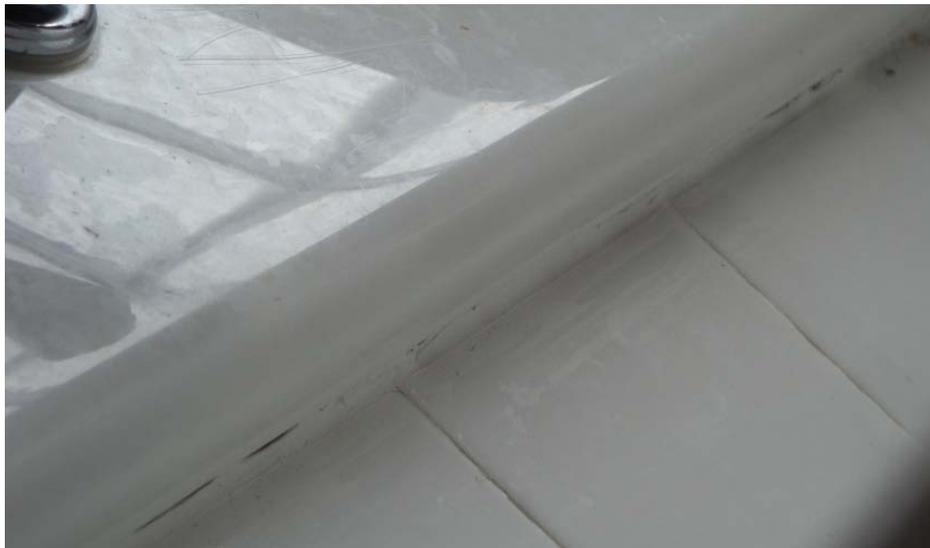
- 2.) The whirlpool tub was poorly installed and is crooked. There is a large gap between the tub and adjacent ceramic tiles which was only caulked. When the tub is full of water and occupied by a person it is very heavy. The tub needs to be installed and supported properly. Have a licensed plumber perform repairs.**

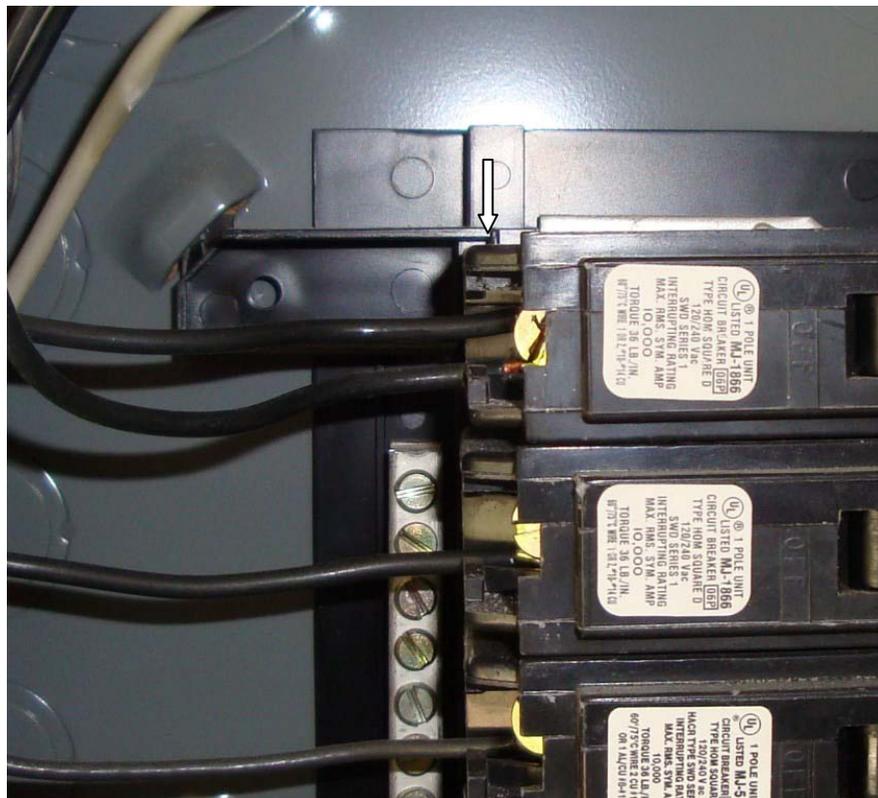
- 1.) The GFCI outlets at the hall bathroom didn't trip when I tested them. GFCI means ground-fault circuit interrupter and is intended to prevent you from being electrocuted at possible wet or damp locations. The outlets should have tripped if they are operating properly. Have a licensed electrical contractor perform replacement or repair.
- 2.) At the main panel box, the top left circuit breaker is "double tapped". Typically only one wire is installed under one circuit breaker screw. Have a licensed electrical contractor perform repairs.

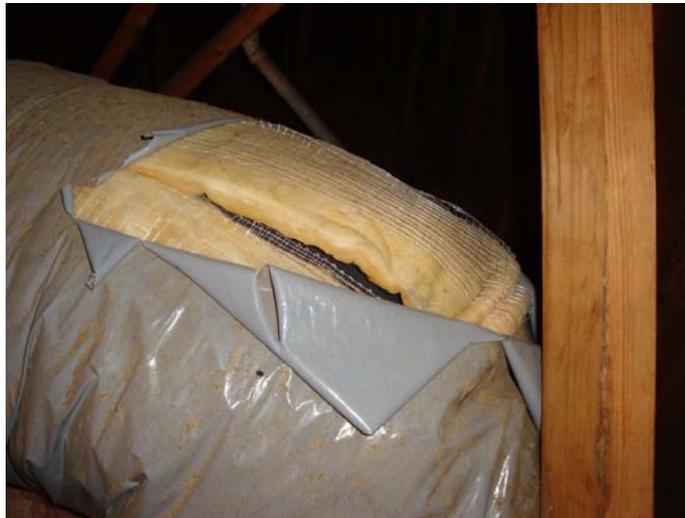
- 1.) **The Heat Pump was operated in the cooling mode. When the compressor at the outside unit started up it made a loud groaning noise. I shut the unit off to prevent any possible damage. This is a problem condition and the compressor is the most important and expensive part of the Heat Pump. Have a HVAC contractor check out this condition and perform all needed repair or replacement.**
- 2.) **The outer covering of the main return line located in the attic is torn and deteriorated. This damage reduces the efficiency of the return line. Have a HVAC contractor perform replacement.**

- 1.) The Heat Pump was operated in the cooling mode. When the compressor at the outside unit started up it made a loud groaning noise. I shut the unit off to prevent any possible damage. This a problem condition and the compressor is the most important and expensive part of the Heat Pump. Have a HVAC contractor check out this condition and perform all needed repair or replacement.
- 2.) The outer covering of the main return line located in the attic is torn and deteriorated. This damage reduces the efficiency of the return line. Have a HVAC contractor perform replacement.

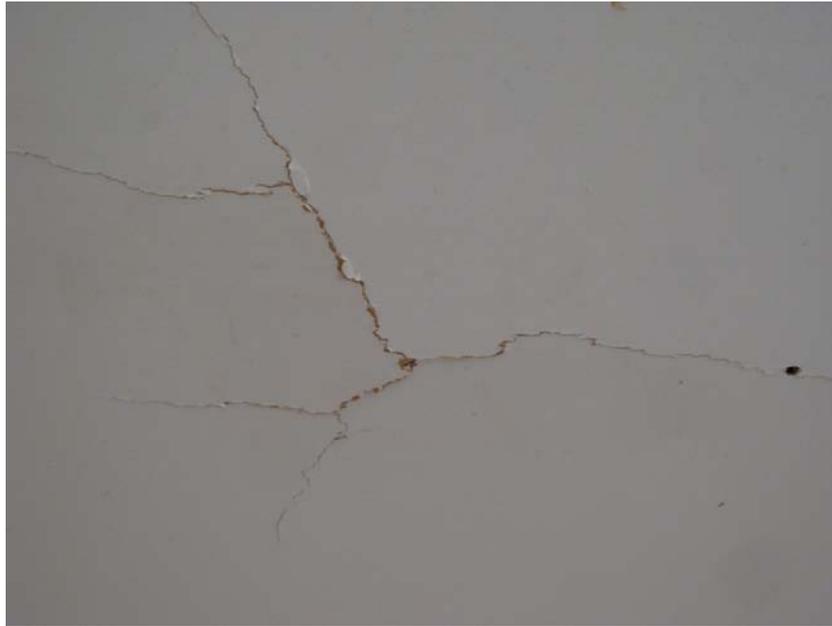
- 1.) There is damage to the ceiling of the garage from someone apparently stepping on it from the attic. Have a licensed general contractor perform repairs.

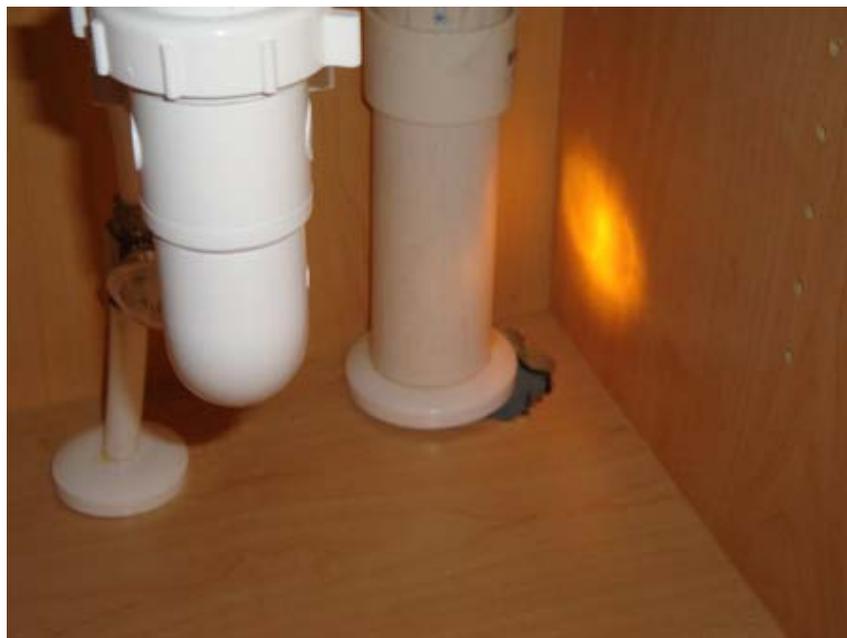
- 2.) Below the kitchen sink the wooden base has a large cut out hole adjacent to the plumbing vent. This poorly cut opening could let vermin and cold air in from the crawl space. Have a licensed general contractor perform repairs.

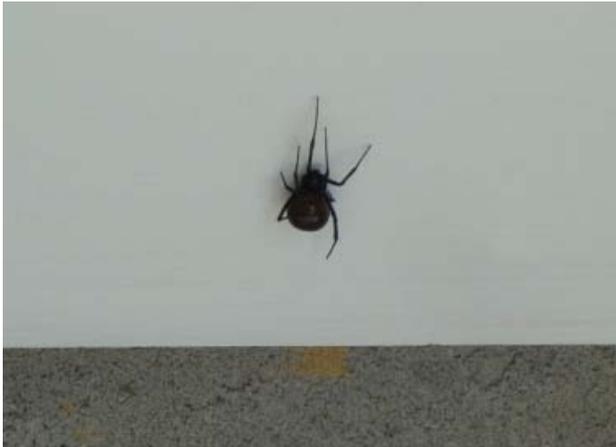
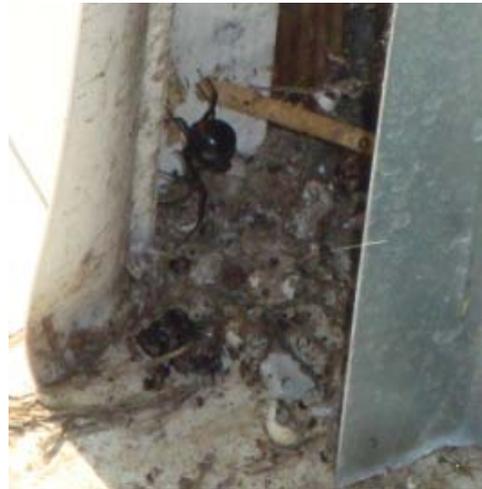
- 3.) **The metal sill of the door from the laundry room to the garage felt weak and flexed when stepped on. This is a possible safety hazard as someone could slip on it when carrying packages or something heavy from the garage. Have a licensed general contractor perform repairs to stabilize it.**
- 4.) **There are several large black widow spiders in the garage. This condition is dangerous since being bit can cause a bad reaction. Have a pest control company exterminate them.**

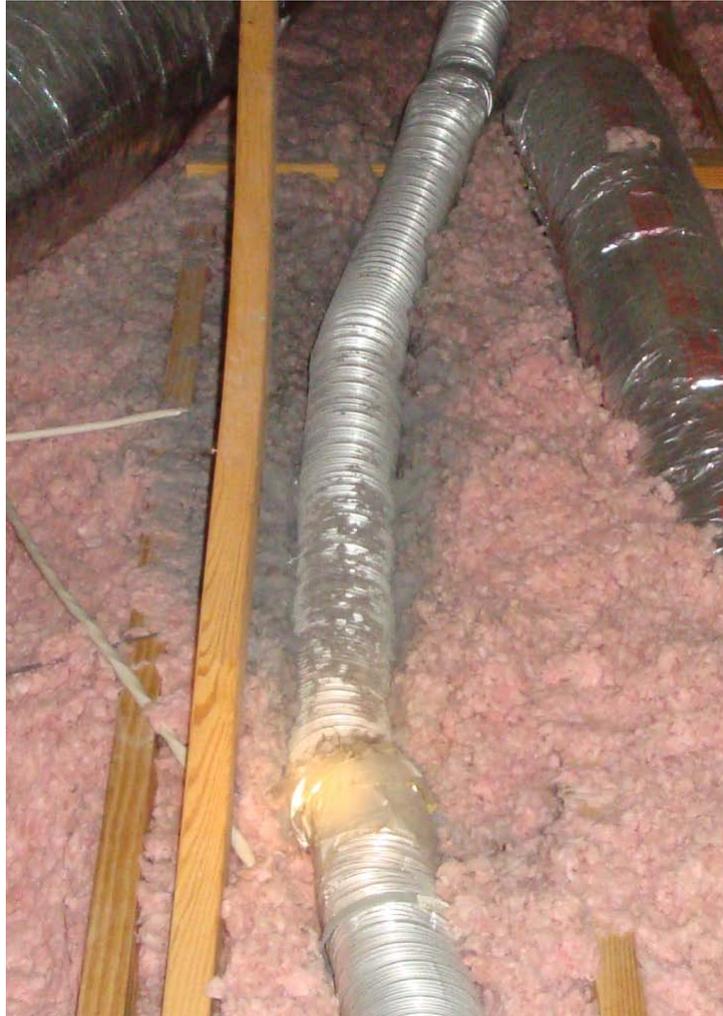
- 1.) **At the attic, the dryer vent is crushed and open at a joint. Lint is present on top of the attic insulation. The open section is greatly reducing the vent's efficiency and the loose lint is a possible fire hazard. Have a licensed general contractor perform replacement and removal of the lint.**

- 1.) At the attic, the dryer vent is crushed and open at a joint. Lint is present on top of the attic insulation. The open section is greatly reducing the vent's efficiency and the loose lint is a possible fire hazard. Have a licensed general contractor perform replacement and removal of the lint.
